# Foundation DRILLING

## Hub Foundation and Great Faith in Micropile Foundations

# Great Faith in Micropile Foundations

By Anthony C. Barila, P.E., Acting Project Manager and John R. McKinnon, General Superintendent, Micropile Division Hub Foundation

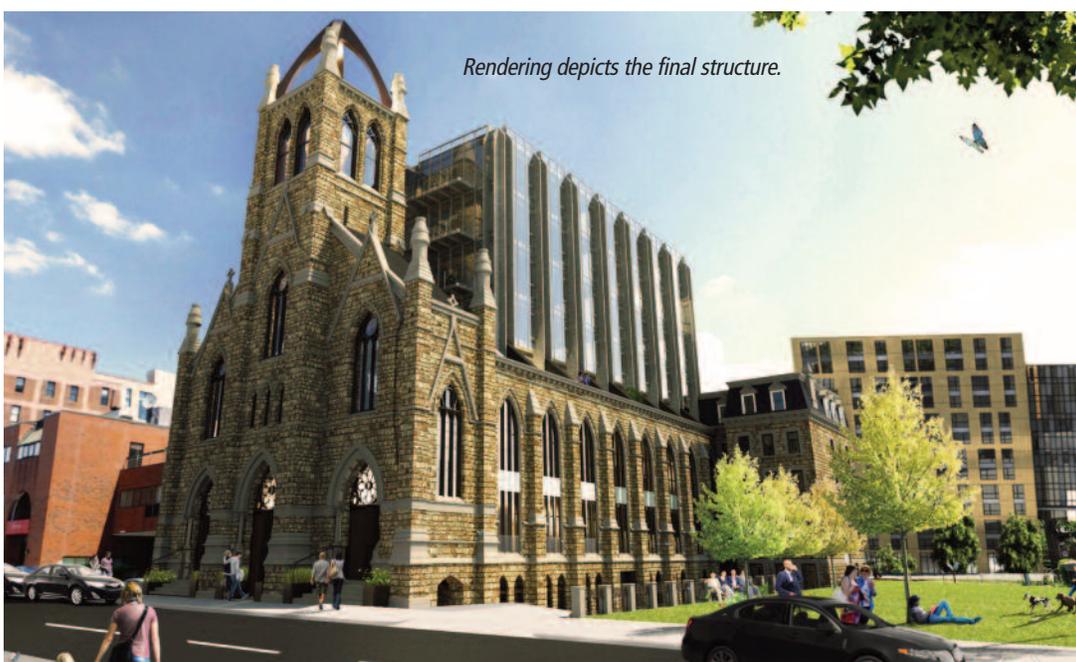
*Rendering depicts the final structure.*

Architects Finegold Alexander of Boston, Massachusetts designed the new project named The Lucas. The plan inserts a new eight story building within the existing Roxbury Puddingstone walls and 100 foot tower. The design retains the architectural qualities of the original structure merging it with a striking steel and glass contemporary interior that rises out of the massive stone walls of

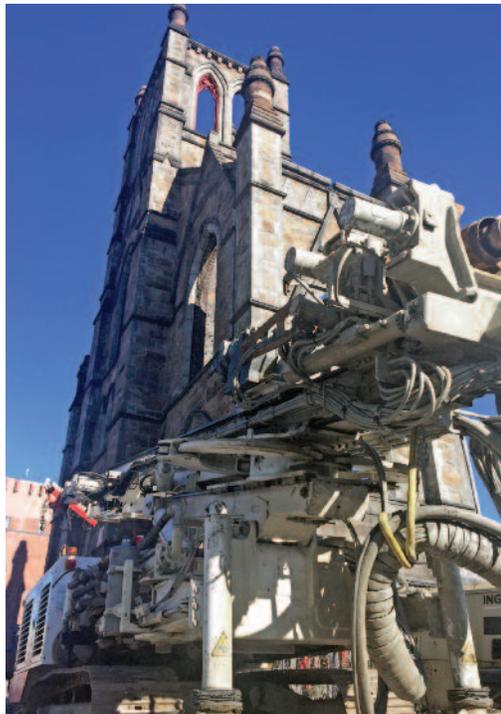
Casagrande C-8 prior to mobilizing into the church.

The piles were drilled with a Casagrande\* C-8 drill rig with a duplex drilling system. Wet-rotary internal-flush methods were utilized to remove the drill cuttings. Hub worked side-by-side with the site contractor to control the drill spoils within the site. The dense fill overlying the clay did not allow the drill water to filter through the soils. A recirculation system was employed to effectively control the spoils and reduce the volume of "wet" spoils that had to be disposed of offsite. Local trenches were excavated adjacent to the pile locations to initially channel the wet spoils to several pits. A centrifugal pump was utilized to pump the wet spoils into one watertight container. The heavy solids suspended within the "wet" spoils were allowed to settle out of the drill water. The "cleaner" fluids were directed into a second container from which a submersible pump was utilized to pump back to the drill rig.

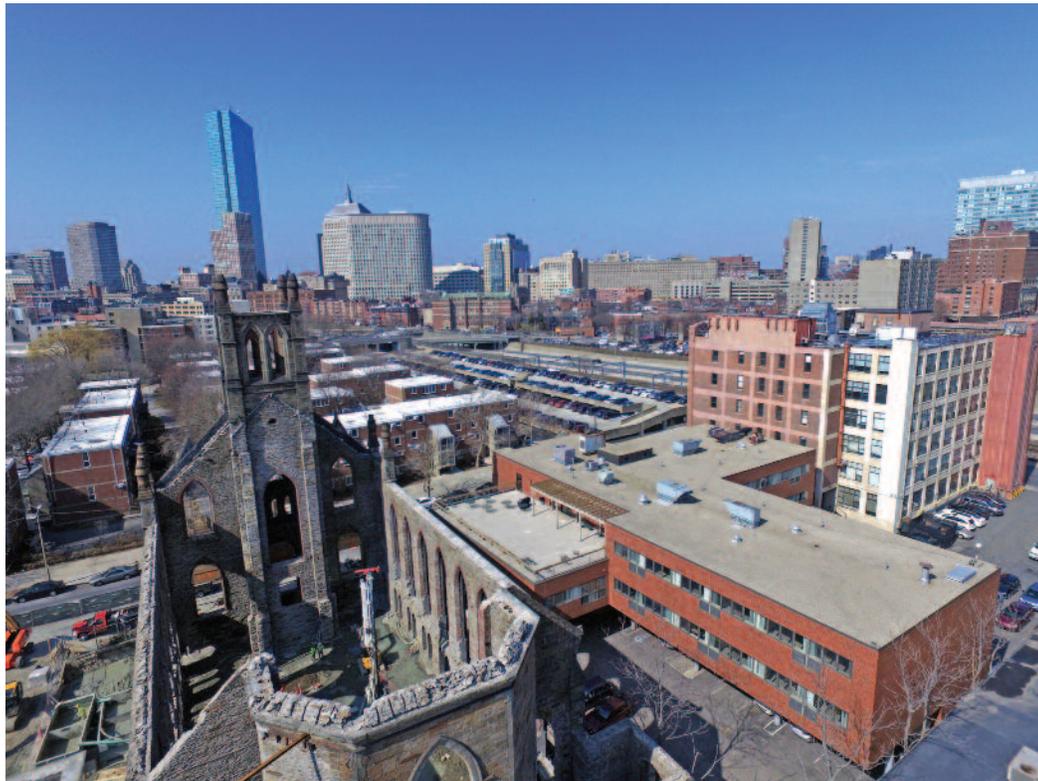
Figure 2. Shows the close proximity of adjacent buildings.

Figures 1 and 2 provide an overhead view of the stone facade structure. Note that except for some of the internal masonry walls within the structure, all internal components of the church were removed. A drone was used for all the overhead photos herein and it was carefully maneuvered to abide by its usage along the flight path to Logan Airport.

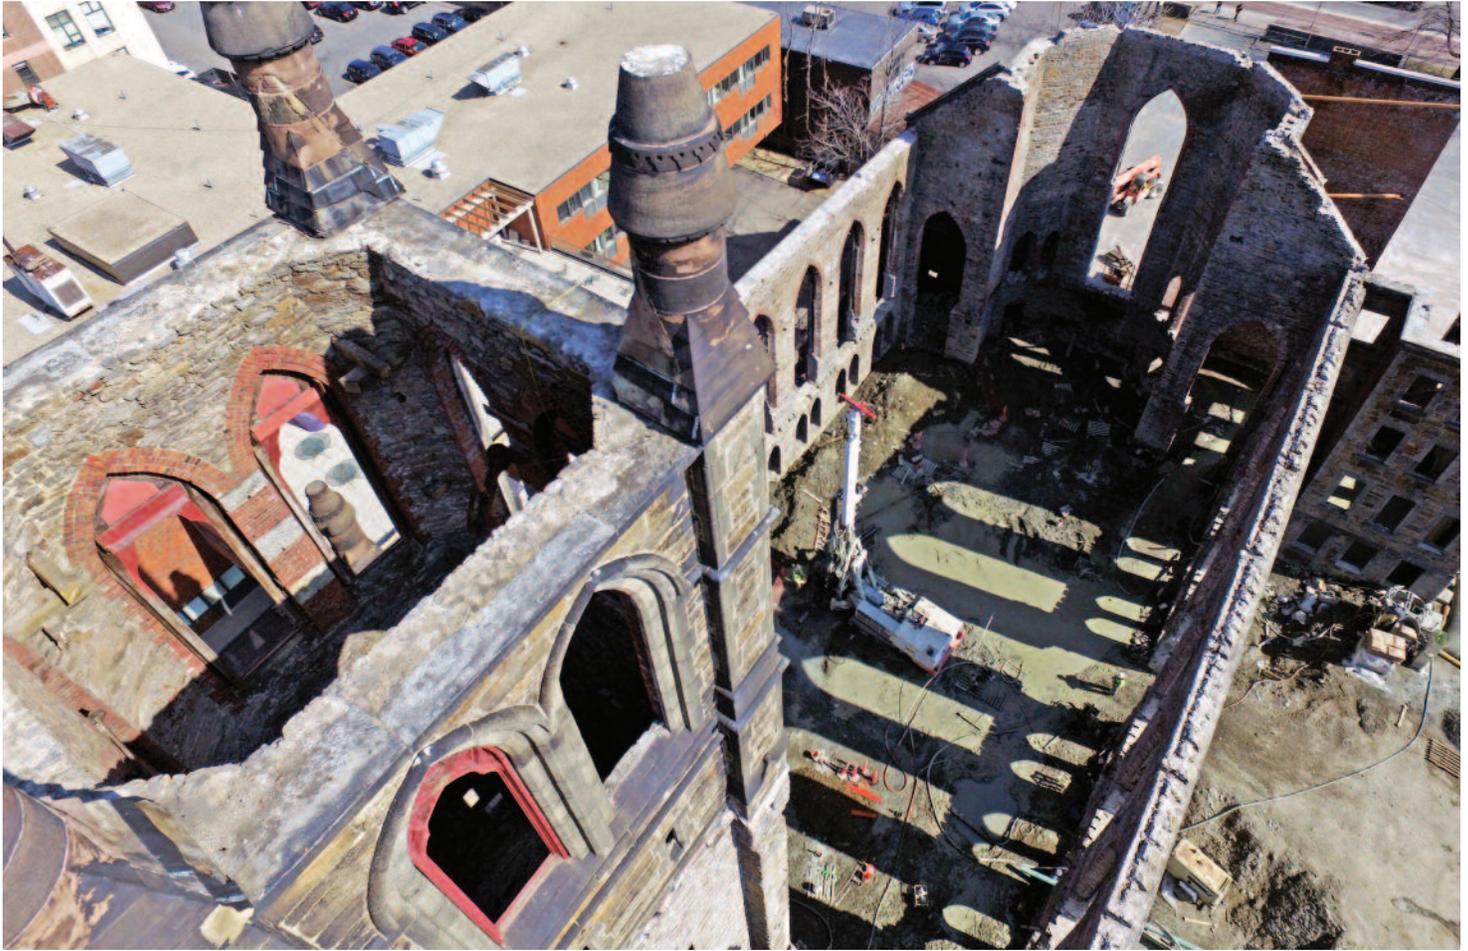
Birds eye view of the drilling from atop the parapet.

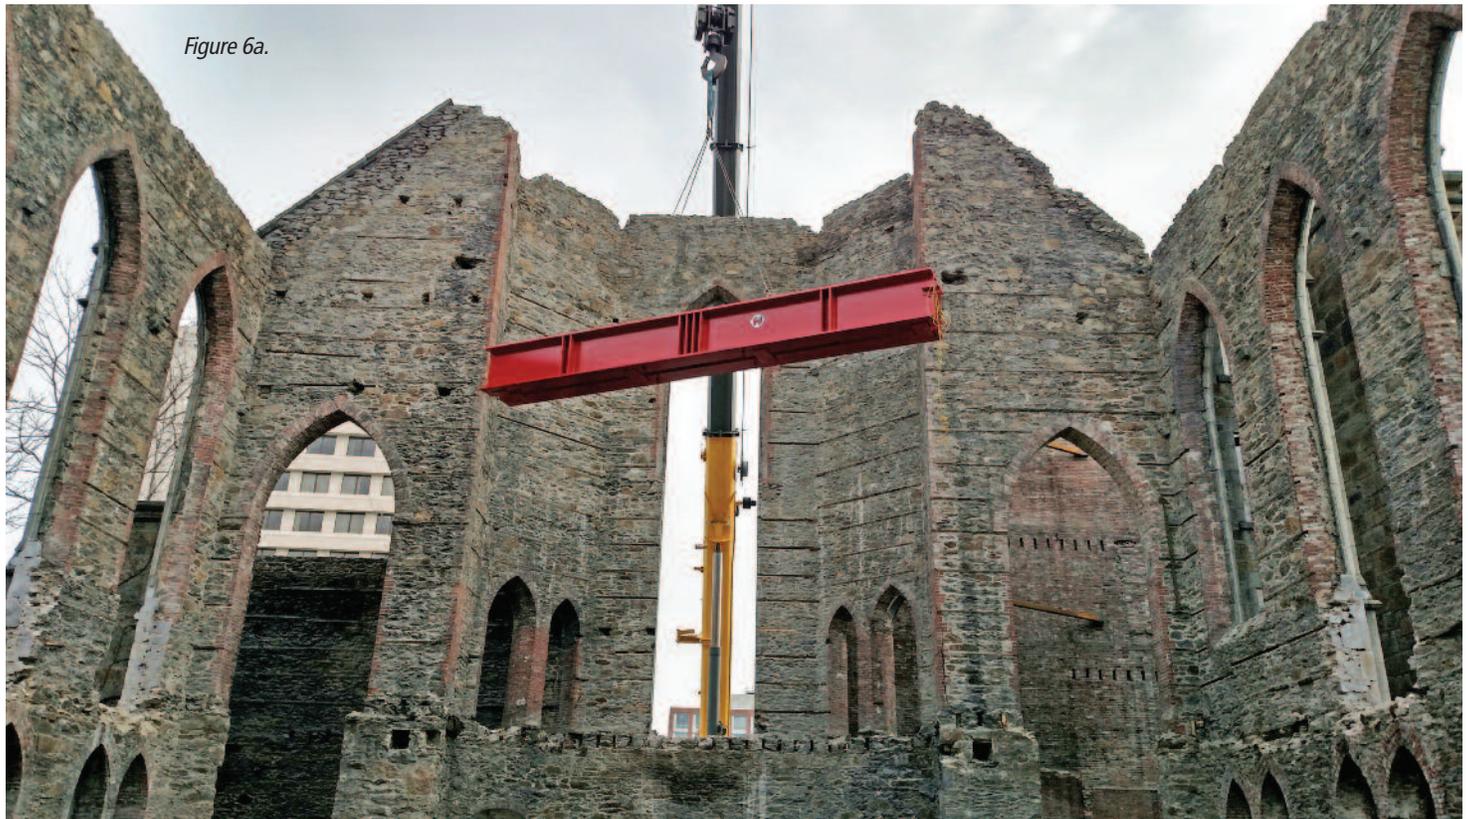
Figure 6a.

through the opening. Therefore, the test beam had to be hoisted with a crane (Figures 6a, 6b and 6c) over the existing facade. A Grove 5275 crane, owned by Hub Foundation, was utilized to lift the test beam. The test was performed on January 19, 2015. Winter conditions in Boston can sometimes be very challenging, especially, with strong and cold wind gusts from the Northeast. The day of the test the high temperature was 15 degrees Fahrenheit with 20 mph winds. A temporary structure was erected over the pile load test frame and heated. Figure 7a and 7b shows the "hermetically" sealed test set-up. Figure 8 gives a view of the cozy interior with all the instrumentation in place during the load test. Throughout the day and into the night, during the long holding periods of the test, the crew enjoyed hot moose meat chili and barbecued specialties. These comforts made the crew and the inspectors very happy.

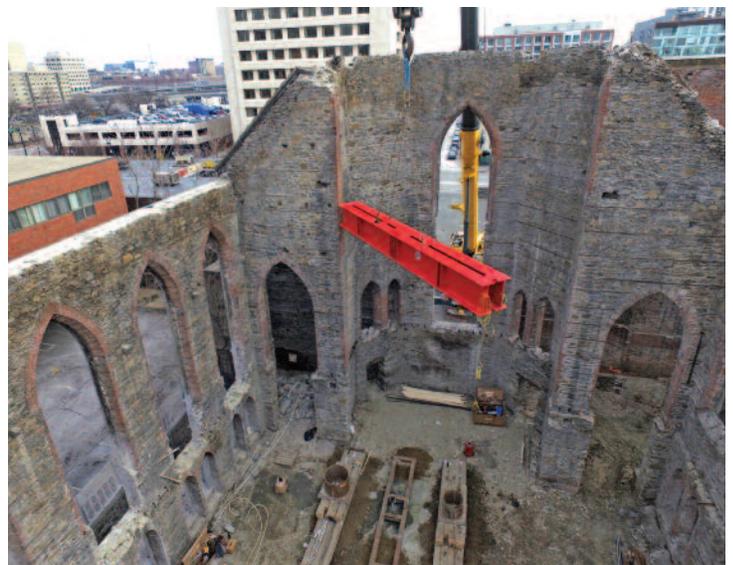
Figure 6c. Showing how close the test bar came to the church walls.

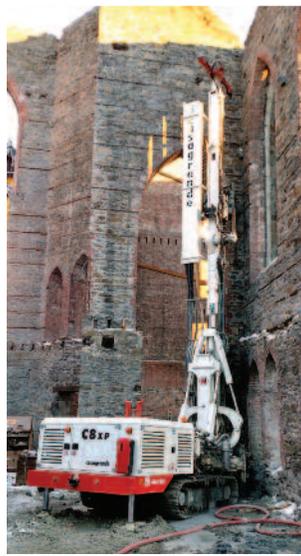
Figure 11. Tight quarters for drill rig.

The perimeter piles were designed to support the new "exterior wall" of the structure. The existing stone facade would be tied to the exterior wall but would not provide structural support to the new structure. The perimeter piles were all located within 24 inches of the edge of the stone facade. Many challenges had to be overcome to successfully install these piles. Extreme care was required, especially, when the drill rig was moved to each pile location. There was concern that any significant impact of the upper portions of the stone walls by the drill mast could dislodge some of the smaller masonry materials. The crew maintained a safe distance from the walls at all times to ensure a safer environment. Figure 11 shows the drill rig exiting the tight opening at the completion of all the production piles.
